Drinking water 2019

Quarter 4

A report by the Chief Inspector of Drinking Water

Significant Risk Audit Programme

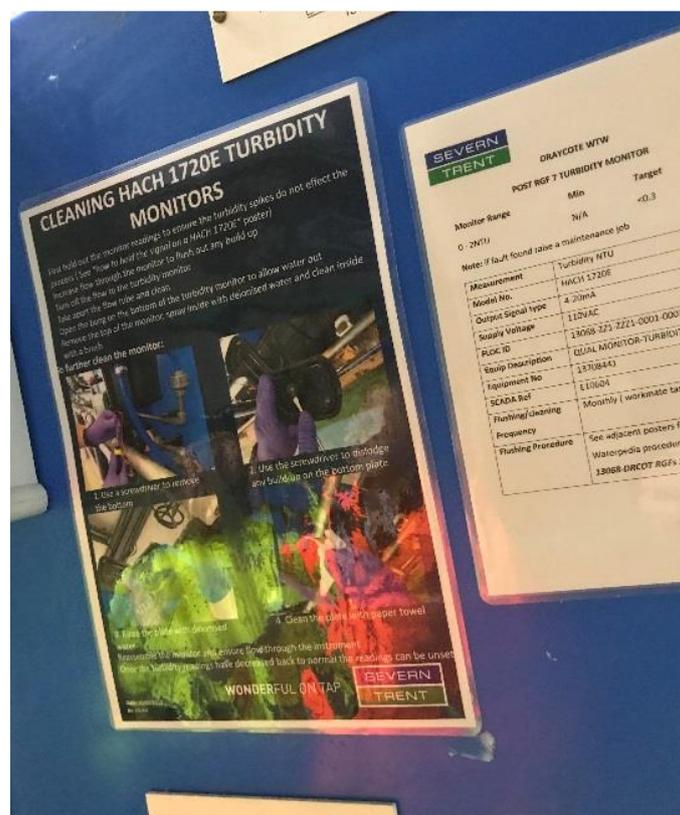
To improve the reliability of turbidity monitors on the rapid gravity filters at Draycote works, Severn Trent Water has a very clear cleaning and calibration guidance sheet mounted on the wall next to each one (Figure 1). We welcome this approach.

Figure 1: Turbidity monitor cleaning guide at Draycote works

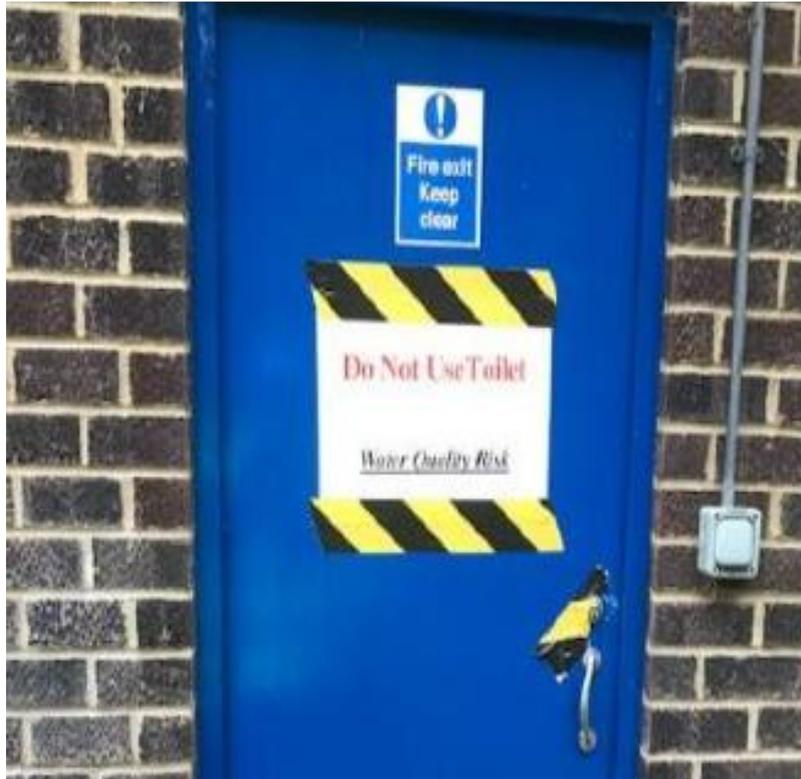
There is a cess pit and toilet close to a Borehole at Thames Water's Dorney Taplow works. This is noted as a risk in its regulation 28 report. An alarm notifies the site controllers when the cess pit level is high. Thames Water plan to replace the cesspit and a sign has been placed on the toilet door to prevent use in the short term. The company has yet to demonstrate to the Inspectorate when this risk will be addressed.

Figure 2: Do not use sign on Thames Waters' Taplow toilet block

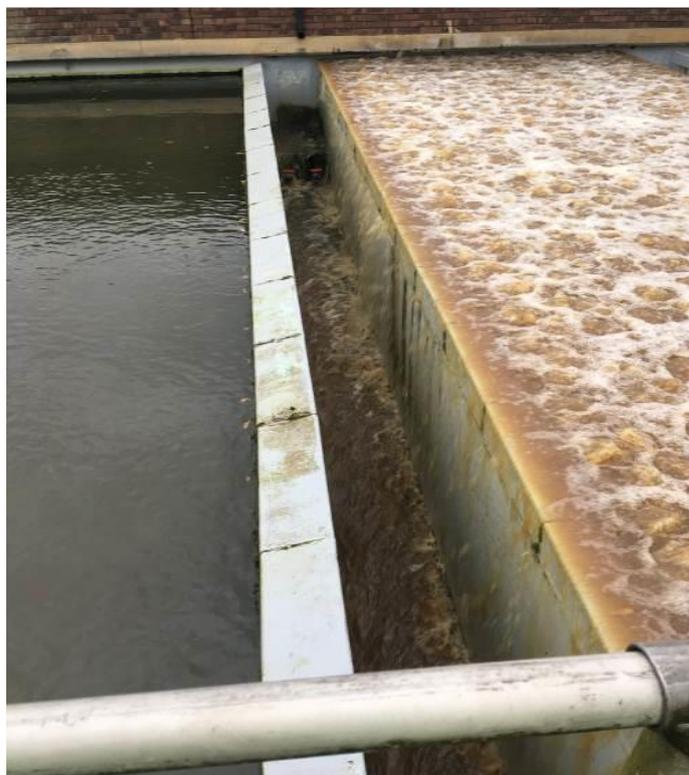
The rapid gravity filters at Southern Water's Beauport works were leaking during backwash risking media loss. The company has put in place plans for suitable repairs to the capping stones and is increasing depth checks in the interim to ensure there is no significant media loss.

Figure 3: Leaks beneath the capping stones at Beauport works

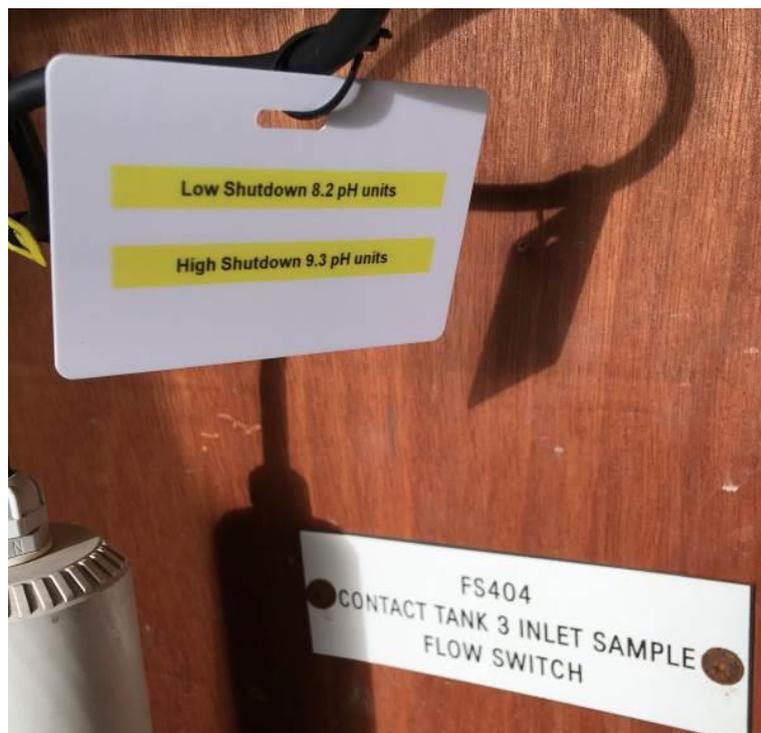
A discrepancy between pH alarms and shutdown set points was found with the contact tank inlet values showing an alarm at 8.2 pH and a high shutdown value 9.3 pH. This exceeds the acceptable pH in the disinfection policy. Following a recommendation to review all set points and shutdowns. The company amended the high shutdown to 8.2, revised the site-specific disinfection policies at all works and trained Senior Scientists, Operational Managers and site operators on the new process

Figure 4: High pH on Beauport works contact tank could compromise disinfection

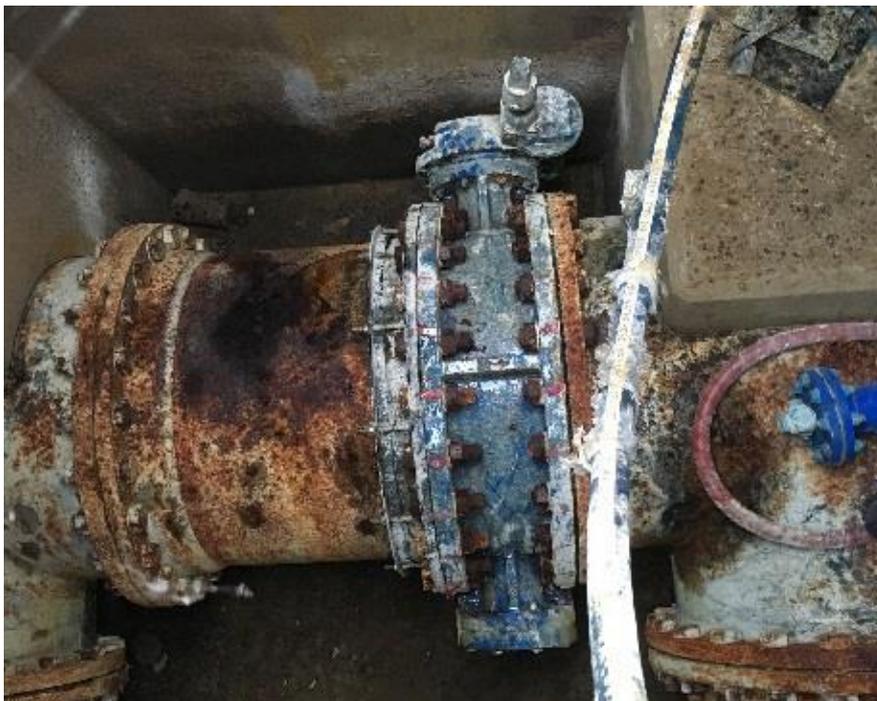
Figure 5: Single bypass valve for the GAC stage at Dorney Taplow works
