Drinking water 2020

Quarter 4

A report by the Chief Inspector of Drinking
Water

Groundwater Audit Programme

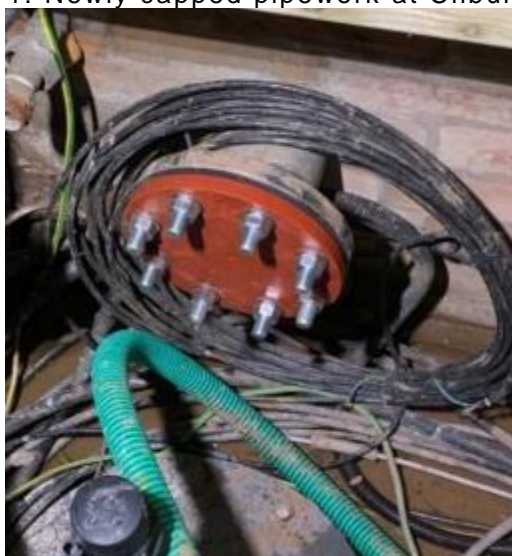
Figure 1: Newly capped pipework at Cliburn works

Inspector's visiting Cliburn works identified uncapped pipework in a borehole chamber and recommended this was addressed. United Utilities subsequently took action to cap the pipework.

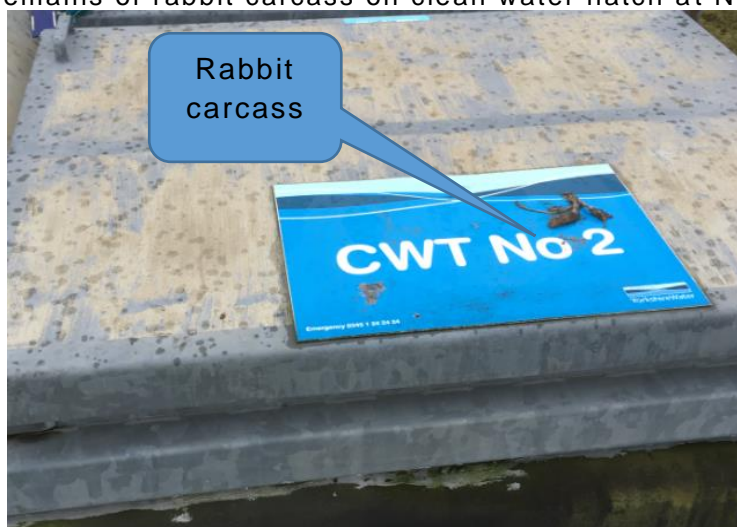
Figure 3: Remains of rabbit carcass on clean water hatch at Nutwell works

Inspectors observed parts of a rabbit carcass on a clean water hatch at Nutwell works and recommended Yorkshire Water review risks and vermin control at its works. Yorkshire Water subsequently reviewed its policy and engaged a pest control contractor to address vermin issues at the site.

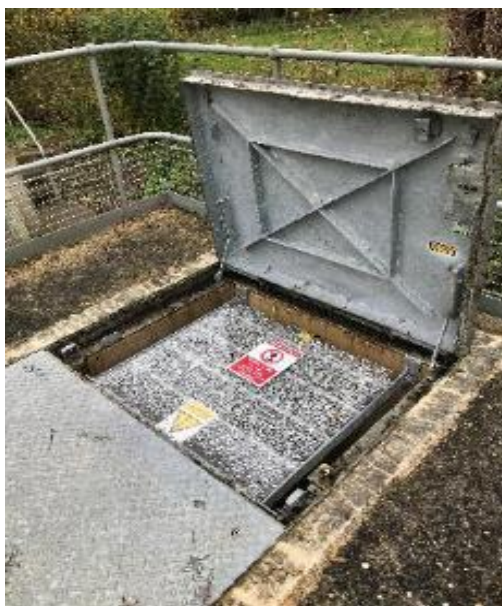
Figure 4: Perspex cover to protect operators at Rodbourne works

At Rodbourne works, Wessex Water had installed a clear plastic cover to protect operators in case of a leak at the chlorine dosing point.

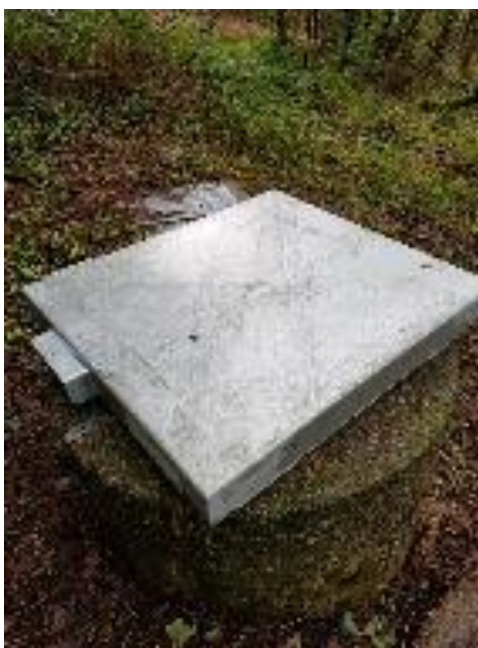
Figure 5: Replacement Technocover on the spring source at Hook works

The spring collection chamber at South West and Bournemouth Water's Hook works was an old concrete structure that was difficult to open, the company avoided the need for the Inspectorate to raise a recommendation by promptly removing the source from supply and instigating a replacement cover for the chamber.
