# Drinking water 2021

Quarter 1

A report by the Chief Inspector of Drinking Water

Drinking water 2021  
Public water supplies for  
England and Wales

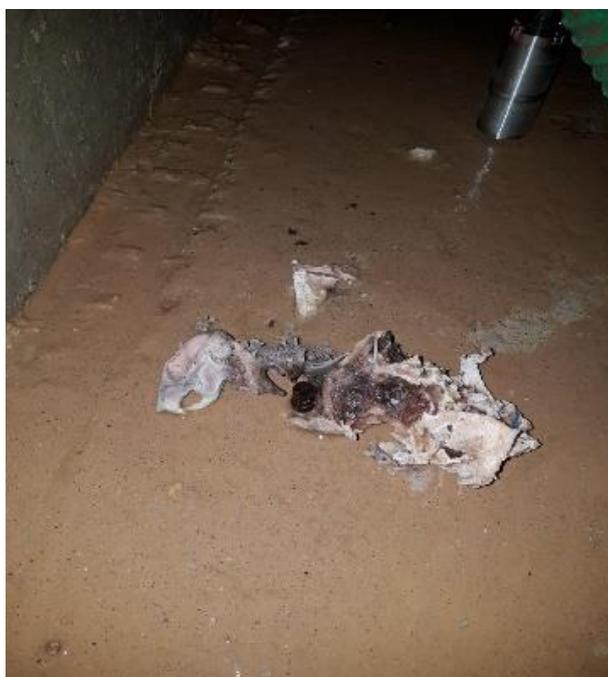
During the inspection a partially decomposed animal carcass, which was believed to be a rat, was found on the contact tank floor.

Photo 1. Animal remains on service reservoir floor

Following the identification and removal of the animal remains the company undertook an internal and external inspection of the contact tank. This inspection identified a single potential point of entry via the contact tank overflow pipe which was not suitably protected. The company installed a temporary mesh before a permanent flap valve could be installed to prevent a recurrence. Following this event, the company instigated a programme of inspections at contact and storage tanks which has identified 115 sites where no suitable protection has been installed on the overflow pipework.

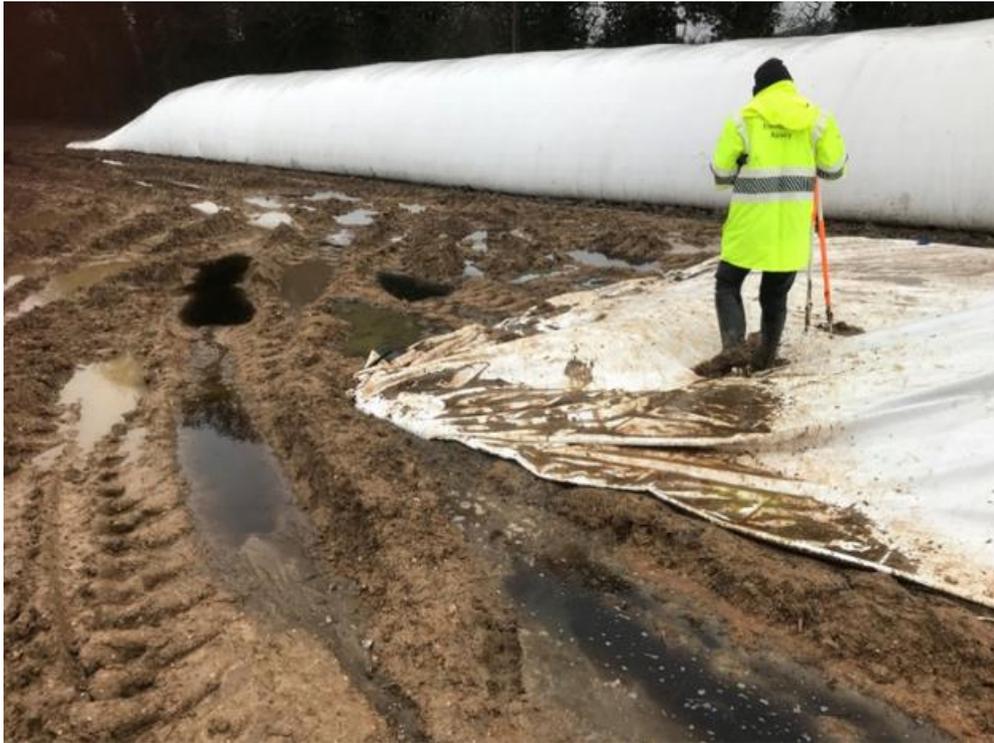
Photo 2: Pooling leachate from a silage bag near Temple End works

Whilst a verbal agreement was made to the company on 12 January 2021 that the bags would be moved, the landowner did not remove them from the field until 8 April 2021. In the intervening period a sump had been dug to collect and pump the leachate, however this was unlined and brought the leachate to within 25 metres of the Temple End borehole, increasing the risk of pollution migration.

The Inspectorate concluded that the initial response to this event was poor. The investigation was limited and did not include rudimentary checks on the catchment that could have identified this sooner.

All companies are reminded to carry out appropriate checks on the catchments of their ground water sources, particularly within the defined source protection zones. In this case the water was rejected by consumers for drinking, the next incident of this kind could involve something far more hazardous to health.
