Drinking water 2021

Quarter 4 October – December 2021

A report by the Chief Inspector of Drinking Water

Public water supplies for
England and Wales

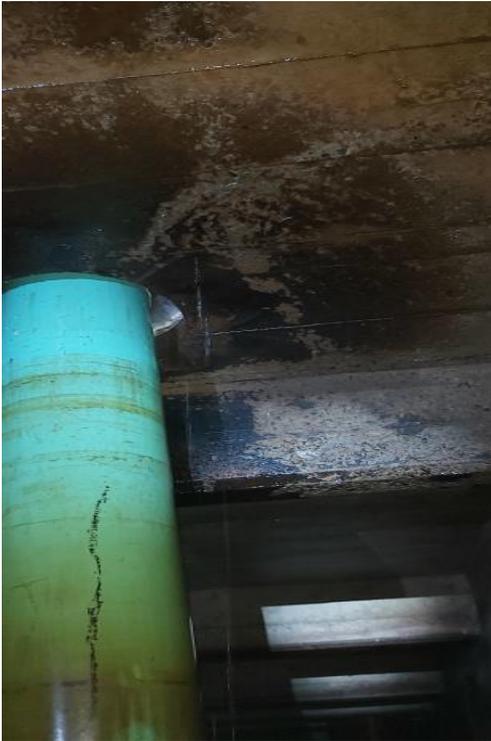
however, several other defects raised were left un-resolved. During the inspection following the failure in October 2021, numerous key defects were identified, including ingress of water from the first stage discharge tank into the contact tank, in the same place as repaired previously.

Figure 1 Leak through soffit slab into inlet gallery Cantref treatment works

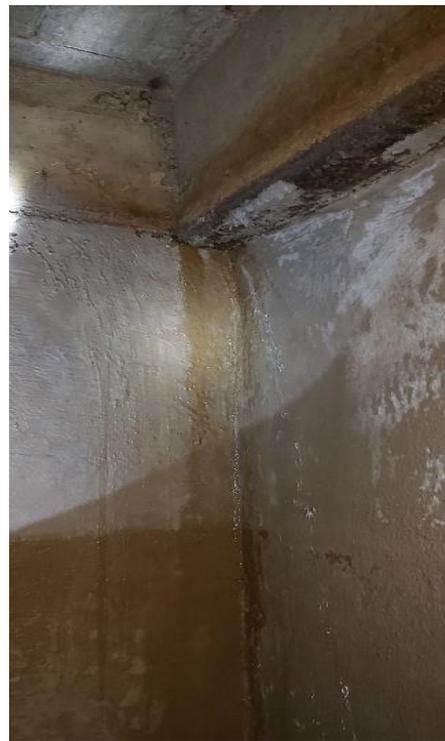
Figure 2 Ingress from interstage filter tank into inlet Cantref treatment works gallery

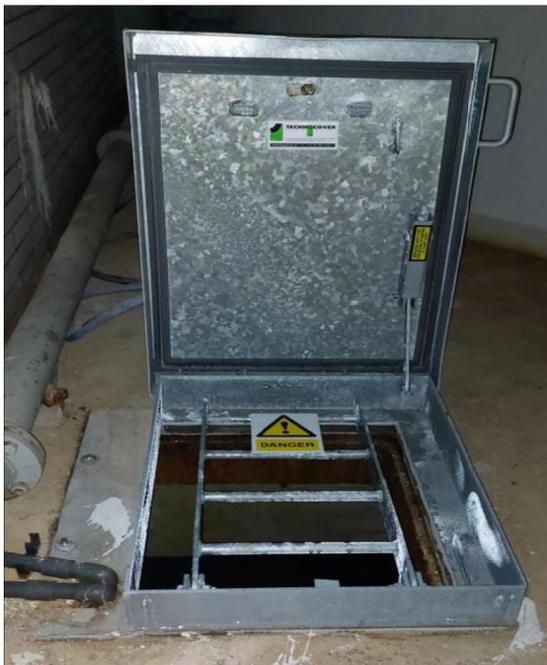
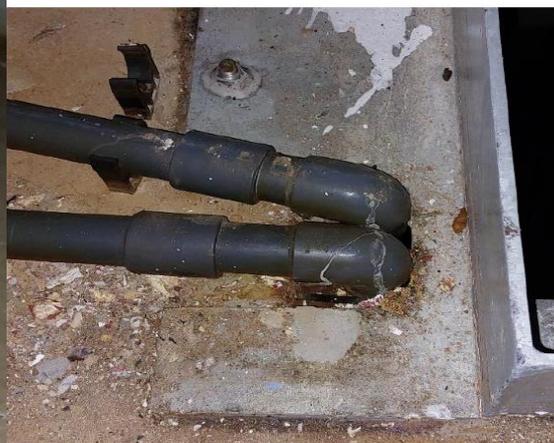
Figure 3 and Figure 4 Phosphoric acid dosing location – not fully airtight and light passing through into tank Cantref treatment works

The company took swift action in removing the works from supply the same day as the failure was reported, thus removing the risk to consumers. The site remains offline until repair work has been completed. Cantref treatment works is due to be replaced by the new Merthyr/Cwm Taff treatment works which is due to be completed by 2030. For assets which are due to be replaced, it is important that these assets should not have their maintenance and repair deprioritised and companies are therefore reminded that assets should continue to be adequately maintained until such time they are removed from supply and decommissioned.

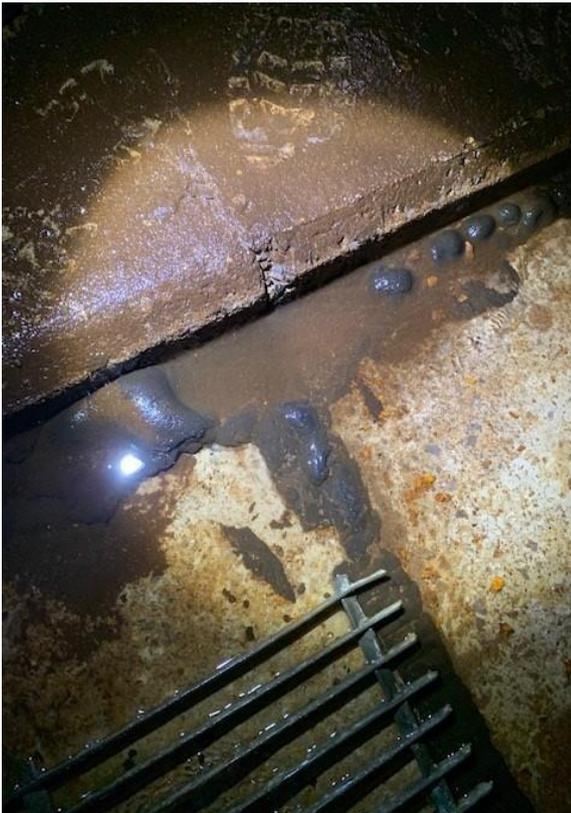
The service reservoir was drained down and an internal inspection carried out. This identified leaks along the entire roof and wall joint, thought to be the cause of the failure. Other issues were also highlighted, such as two abandoned inlet mains requiring cutting and capping. The reservoir was last internally inspected in March 2016.

Figure 5 Defective bitumen joint
Fitzroy service reservoir

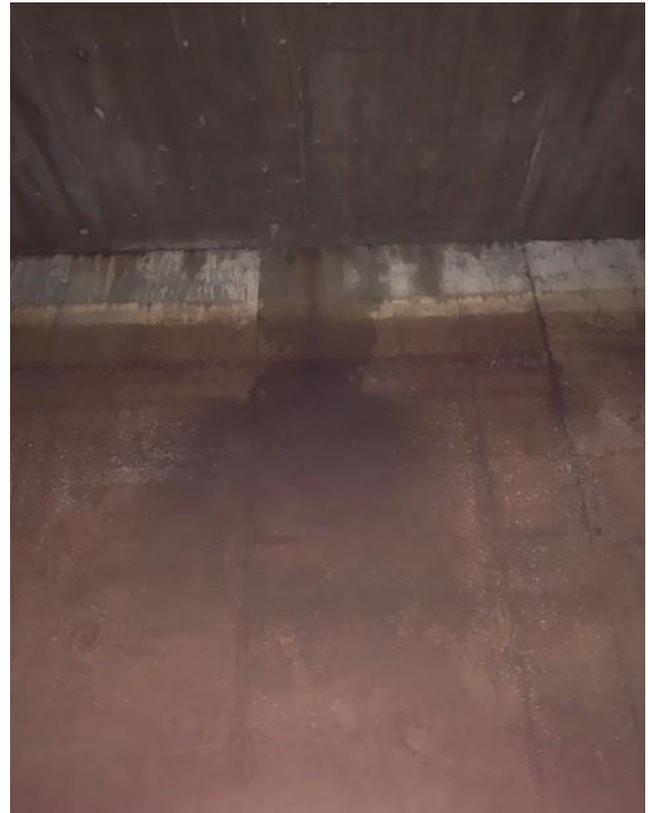
Figure 6 Defective bitumen joint
Fitzroy service reservoir

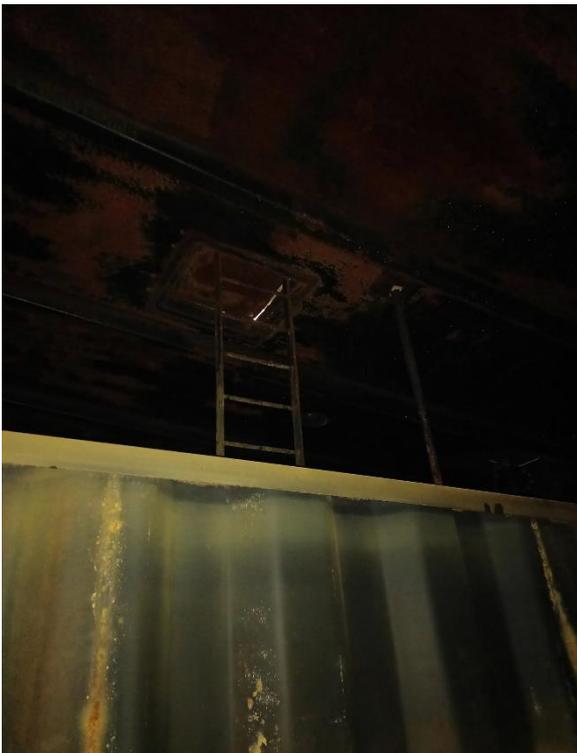
10 coliforms were detected at Hafren Dyfrdwy's Welshpool Yr Allt service reservoir in November 2021. Both cells were last internally inspected in 2015. The company attempted to remove the service reservoir from supply, however the bypass was found to be inoperable. Following work to resolve this, the reservoir was removed from supply in January 2022, nearly 10 weeks after the failure was reported. The company were given a suggestion in an audit report in December 2021, to include operability checks for critical valves which may prevent recurrences of this in the future. The internal inspection highlighted a broken washout pipe, which is a potential point of ingress, overgrown vegetation reaching the tank, making it difficult to fully inspect the asset from the outside, and a point of ingress through the roof hatches, from which daylight could be seen from the inside. This is a good example of why critical valves should be checked for operability and companies should ensure that wherever possible, service reservoirs and tanks can be removed from supply when required.

Figure 7 Entry hatch (closed) showing daylight visible through gaps
Welshpool Yr Allt service reservoir

This asset is due for replacement in AMP7 and is another example of an asset which has failed whilst awaiting renewal.

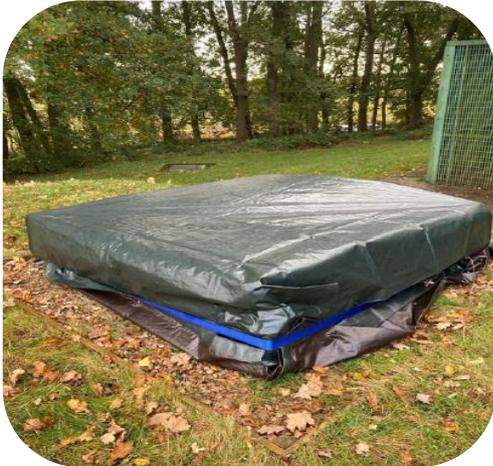
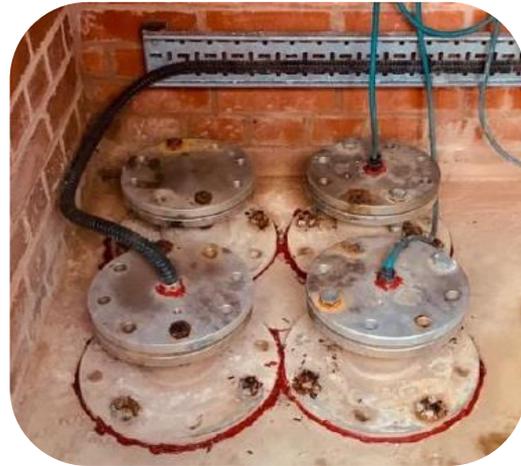
took steps to address ingress risks around access hatches and the level probes (See Figure 8 and Figure 9).

Figure 8 and Figure 9 Precautionary ingress prevention measures at Budby works

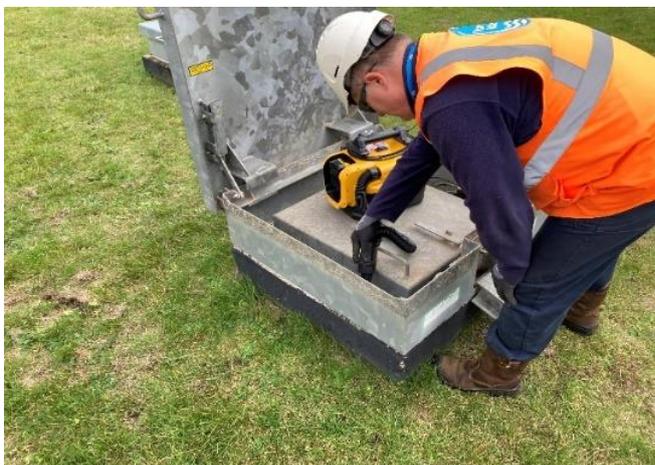
The audit team were unable to establish the frequency of access hatch inspections at Thames Water's sites with documented inconsistencies requiring weekly, monthly or quarterly inspections, however, no records could be located to confirm which, if any, had been checked. A recommendation was made to implement and record a suitable inspection regime. Good practice was observed related to hatch cleaning. See Figure 10.

Figure 10: Hatch cleaning at Thames Water

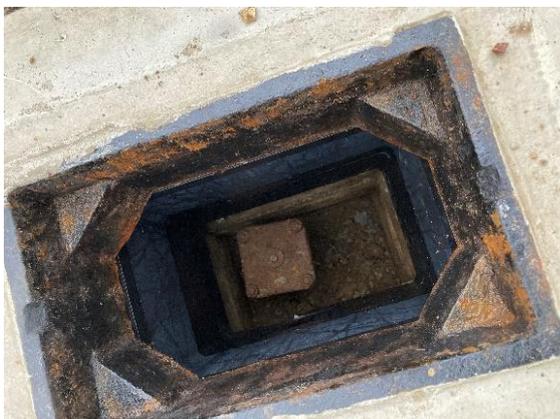
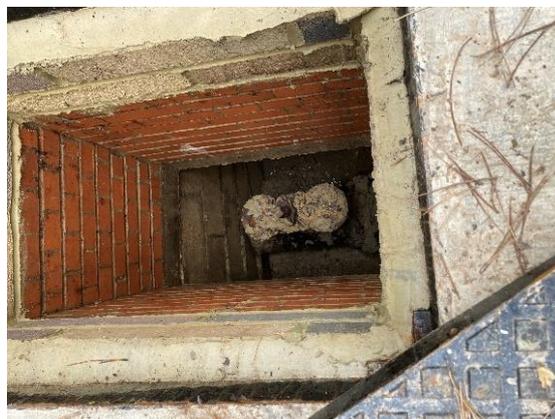
A recommendation for the company to introduce a suitable policy for air valve inspection and maintenance using a risk-based approach was made with a suggestion that the company takes heed of guidance laid out in the Principles of Water Supply Hygiene including paragraphs 8.1 and 8.3 along with Technical Guidance Note 2. Both air valves observed at the audit were heavily corroded externally. As shown in Figure 11 and Figure 12.

Figure 11 and Figure 12 Corroded air valves at Thames Water service reservoirs

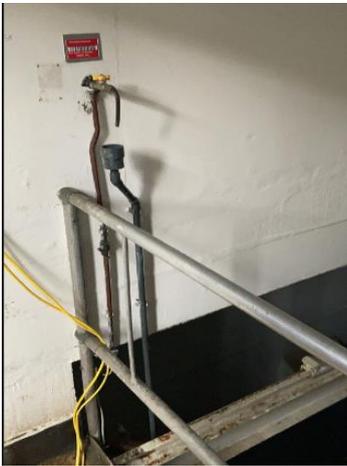
The sampling facilities for Amersham service reservoir (Figure 13) do not comply with several aspects of the company's own policy document. There is no sink, no anti-splash plate behind the tap and sampling is likely to be impeded by the barrier rail in close proximity to the tap. There is insufficient space between the tap outlet nozzle and the small drainage funnel for adequate collection of samples, an arrangement considered wholly unsatisfactory for the purpose of regulatory sampling. A recommendation that these facilities are brought up to the company standard was made. Another recommendation was made for the company to review the sampling arrangements at all sites to ensure that that they are in line with the company's own standard.

Figure 13 Amersham sampling point

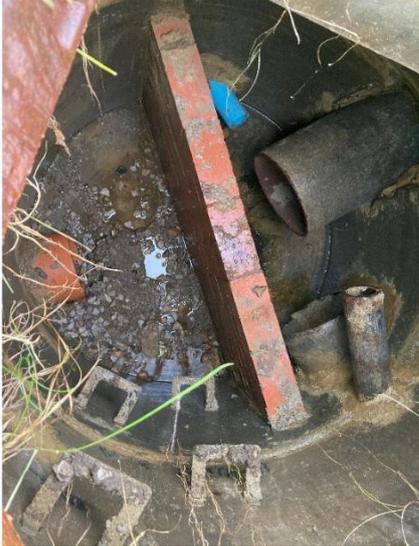
At Oldfield works overflow and wash out arrangements for the clean water tanks were inspected. At the time of the audit, none of the washout, outlets or overflows from either compartment were protected from vermin or from ingress of surface water (Figure 14). It was not able to be confirmed during the audit which pipework in the chamber shown in Figure 14 was from which tank or

whether the pipework was potentially from other parts of the treatment or the sludge process. The company have since confirmed which overflows and washouts enter the chamber and which pipework is the outlet of the chamber to the soakaway. The company have now also installed 400 µm mesh protection to prevent vermin entry. Companies are reminded that outlet and washout chambers can present a risk to water quality if pipework is not adequately protected.

Figure 14 Outlet chamber at Yorkshire Water's Oldfield works.

At the time of the audit there was no vermin protection, this has since been installed.

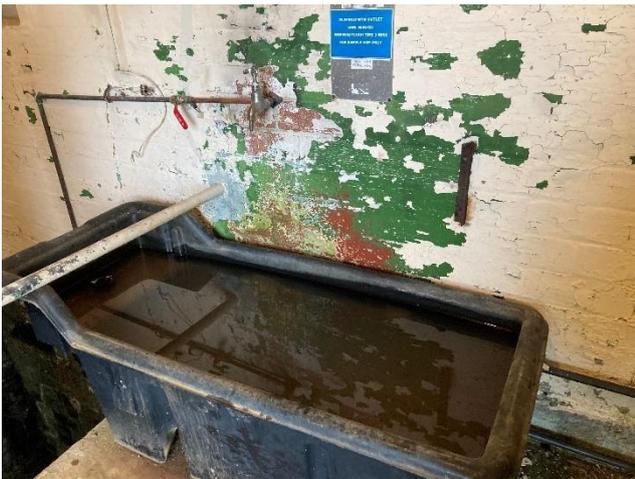
The regulatory sample point at Oldfield works was in a poor state, far below expected industry standards (Figure 15). Since the audit the company have committed to installing new tun dishes and sampling housings with improvements being made to the regulatory sample point building. The Inspectorate suggested that that the company implement a checklist for sample points which covers the surroundings of regulatory sample points to ensure they are clean, tidy, and well lit. The Inspectorate expects all companies to be working towards dedicated, clean sample kiosks for all regulatory compliance points. Adequate space and provisions to aid sampling and suitable sample tap drainage should be installed. The Inspectorate does not expect to see regulatory sample points in the condition shown in Figure 15 and therefore companies should complete upgrades where necessary.

Figure 15 Surroundings of regulatory sample tap at Yorkshire Water’s Oldfield works that are below the expected industry standard

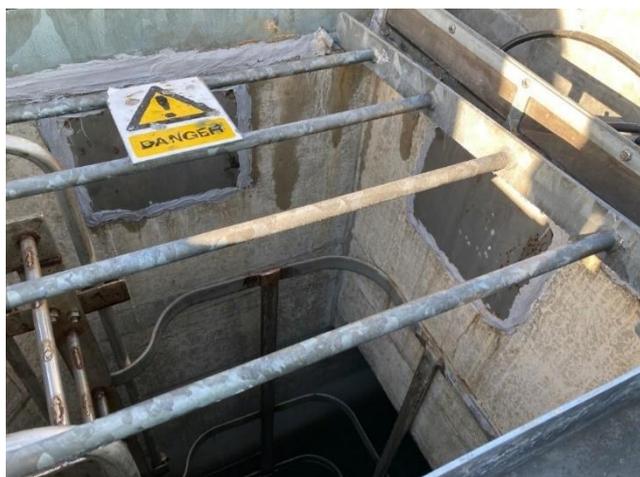
Horton Bank service reservoir showed evidence of seepage and ingress into the chambers. The ingress points appeared to be from previous repairs. There was no evidence that these defects had been identified on the proactive inspections by network teams. The company said at the time of the audit that the water on the hatch upstands was condensation. However, condensation does not present the same pattern/distribution on the concrete upstands as observed on the day of the audit (see Figure 16). The Inspectorate recommended that the integrity of the repairs on Horton Bank service reservoir were checked with flood testing and that any ingress was rectified to maintain the standards for wholesomeness.

Figure 16 Evidence of repairs and seepage at Yorkshire Water's Horton Bank service reservoir

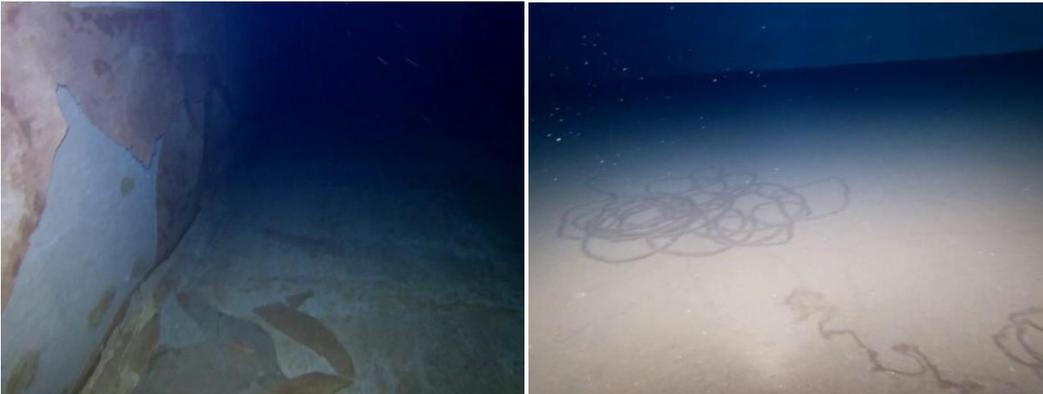
The company conducted an ROV survey in August 2020 which identified a leak between the seal on the access hatch and upstand. Internally, the survey identified where concrete render had come off the wall in places and silt near the reservoir outlet and evidence of snail activity or similar (Figures 17 and 18).

Figure 17 and Figure 18 Render coming off walls and evidence of snail or similar activity from August 2020 ROV survey

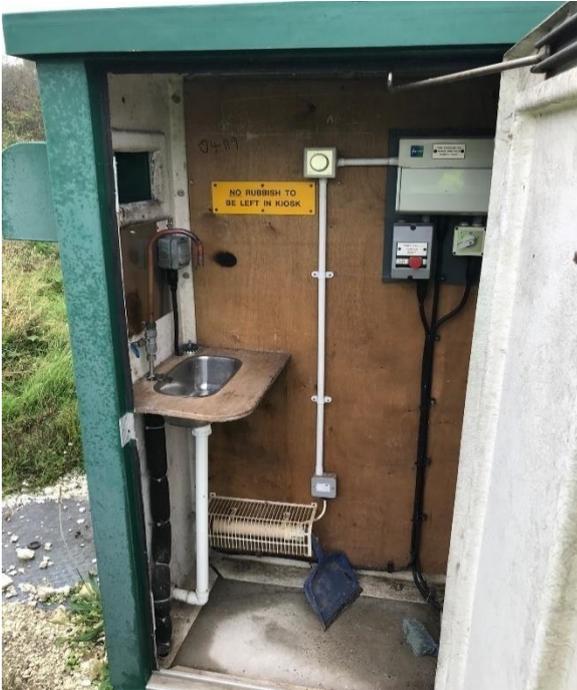
Figure 19 Sample tap facilities Patcham Mid service reservoir

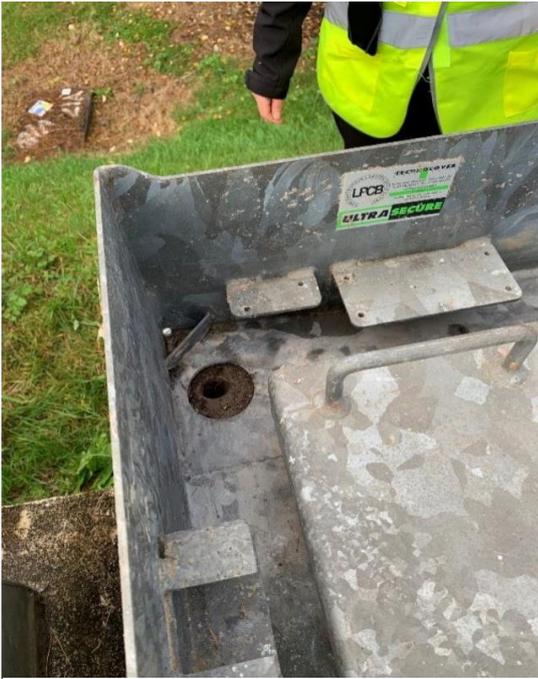
For both single cell tanks; the Inspectors found these in fair condition, with comments regarding maintenance of hatch sealant and one recommendation was given regarding a possible ingress route into an outer hatch via cable ducting.

Figure 20 Unsealed cable ducting in exterior hatch at Llanstephan service reservoir

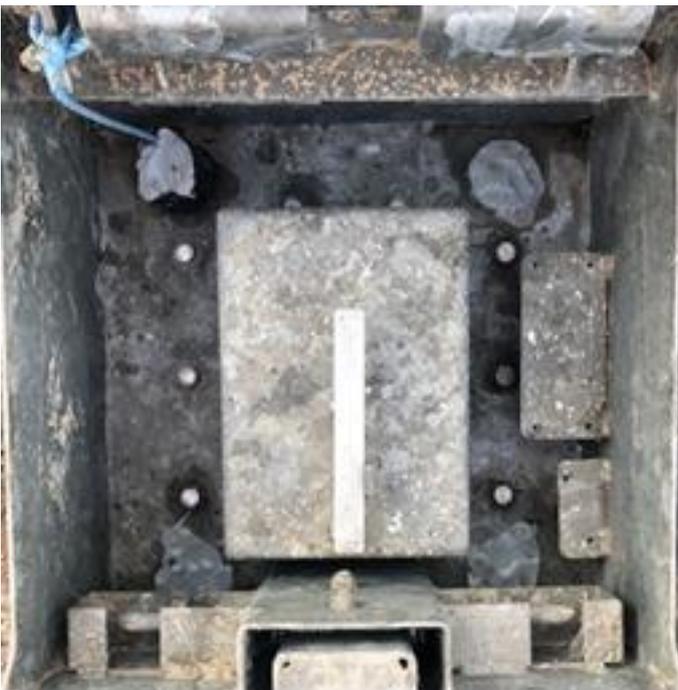
Figure 21 Sealed cable ducting in Llanstephan service reservoir (different hatch to Figure 20) post audit

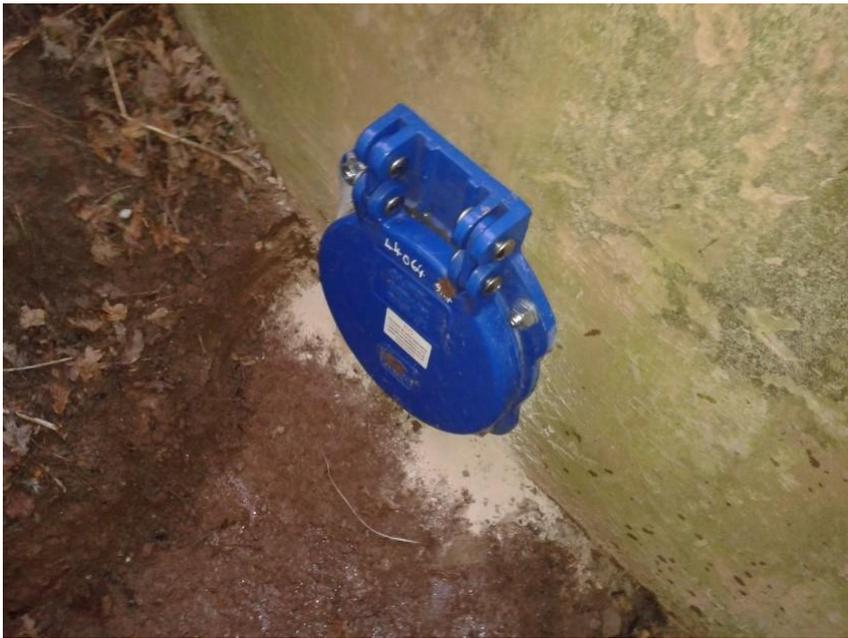
Flap valves were in place and in good condition at both assets.

Figure 22 Flap valve at Llanstephan Service Reservoir
