PRIVATE WATER SUPPLIES – CASE STUDY 2013/14

Land agents – a sectorial group in need of water safety information?

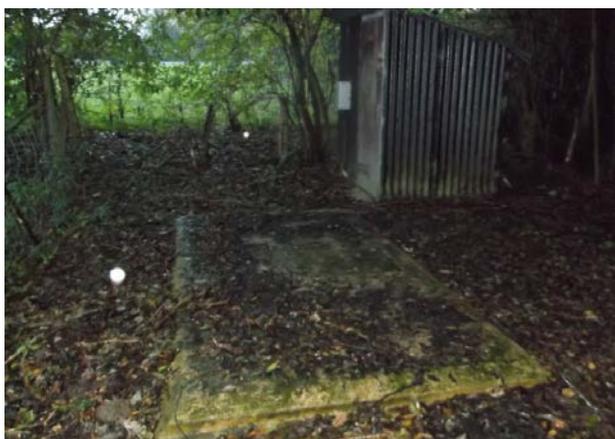
Figure 22: Situation of tank

In October, after power was restored to a public supply booster station, an operational sample was collected by the water company from a farmhouse and found to contain *E.coli*. On investigation the company identified that the contamination was likely to be arising in two privately owned tanks providing water to the farmhouse and three other properties. Boil water advice was given to the occupiers of all four properties who were also provided with a bowser and bottled water. It was found that the metered mains supply filled an underground break pressure tank. Water from this tank was then pumped to another storage tank and from there water fed by gravity to the farmhouse, the other three properties and six cattle troughs.

Figures 22 and 23 illustrate the poor condition of the underground tank. A temporary overland supply was put in place comprising a new temporary water storage tank feeding the existing

booster pumps and bypassing both existing tanks. The water company verified that this temporary arrangement was compliant with fittings regulations. The water company and local authority then established a co-regulation arrangement for managing the ongoing risk. This involved the local authority assessing the supply as a 'temporary supply' against the Code of Practice for Provision and Management of Temporary Water supplies and Distribution Networks (BS 8551:2011) with the water company sampling four times a year alongside checks and, if necessary, enforcement of the fittings regulations. This co-regulation arrangement was considered necessary because information had come to light demonstrating how the land agent had ignored previous advice from consultants in 2012 about the need to improve the water supply arrangements. The temporary supply and co-regulation arrangements will remain in place until a permanent supply is provided that is demonstrably compliant with the fittings regulations.
